> WEAR DEBRIS ANALYSIS OF GREASE LUBRICATED BALL BEARINGS

Advanced Technology Office Support Equipment Engineering Department Haval Air Engineering Center Lakehurst, New Jersey 08733

12 APRIL 1982

Final Report AIRTASK A3400000/0518/1753537401

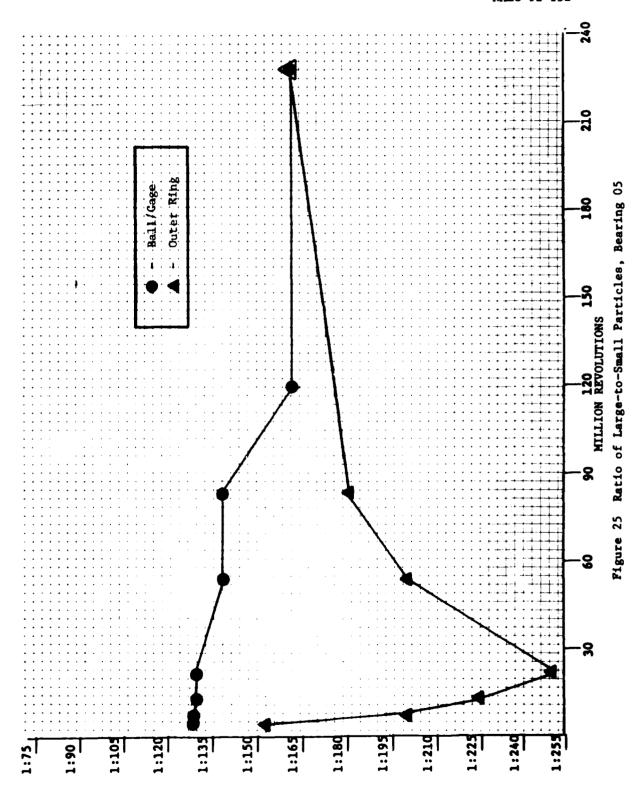
Figure 26 SEM Photomicrograph of Ferrograms From Bearing 05 Cage/Ball Sample, After Various Revolutions (Continued - Sheet 3 of 3)

Throughout this period, normal wear progressed, marked by stepped increases at the 52- and 80-million revolution sample points. Of particular note was the continued presence of wear-in type particles. This may be the result of the dismantling and reassembling of the bearing at each sample point. The wear severity increased markedly from the 52- to the 80-million-revolution samples, indicating an increase in the rate of wear particle generation, although the particle sizes stayed approximately the same (see Figures 26B and 26C). A large quantity of abrasive wear was noted in the 80 million revolution sample.

1. Starting with the 120-million-revolution sample, an unstable wear condition was observed. The condition of the grease had begun to degrade slightly, causing some problems in obtaining accurate particle analysis. However, at the termination point, the wear analysis of the particles indicated that there appeared to be no appreciable surface degradation of the bearing (see Figures 26D and 26E). Particle ranges for this final period are presented in Table 8.

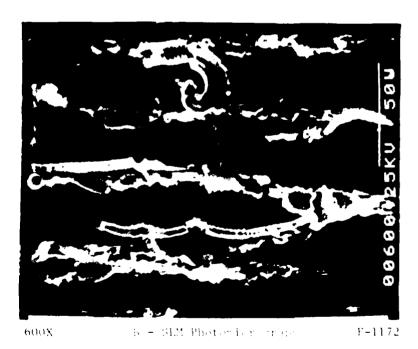
Figure 35 Photomicrograph and SEM Photomicrograph of Ferrogram From Bearing 96 Ball Cage Sample, After 52 Million Revolutions

The wear severity (17,000) and the ratio of large-to-small particles (1:160) were both very high in number, compared to the values for the same sample period in bearing 05. The size and amount of abnormal wear particles (especially fatigue and severe wear particles) was readily observable (see Figure 35). Temper coloration was observed in several of the larger particles, indicating a high temperature condition in the bearing. This information indicated that the bearing was wearing at an abnormal pace.
